State of California
The Resources Agency
DEPARTMENT OF WATER RESOURCES
DIVISION OF SAFETY OF DAMS

INSPECTION OF DAM AND RESERVOIR IN CERTIFIED STATUS

Name of dam Oroville Dam Dam No. 1-48 County Butte
Type of dam Earthfill Type of Spillway Gated Concrete Weir and Chute
Water is 114.32 feet below spillway crest and 222.52 feet below dam crest.
W.S. 699.48 feet
Weather Conditions Partly cloudy and cold
Contacts made Alex Samaan, OFD; David Panec and Mike Urbano, O&M.
Reason for inspection Periodic Evaluation (1st inspection)

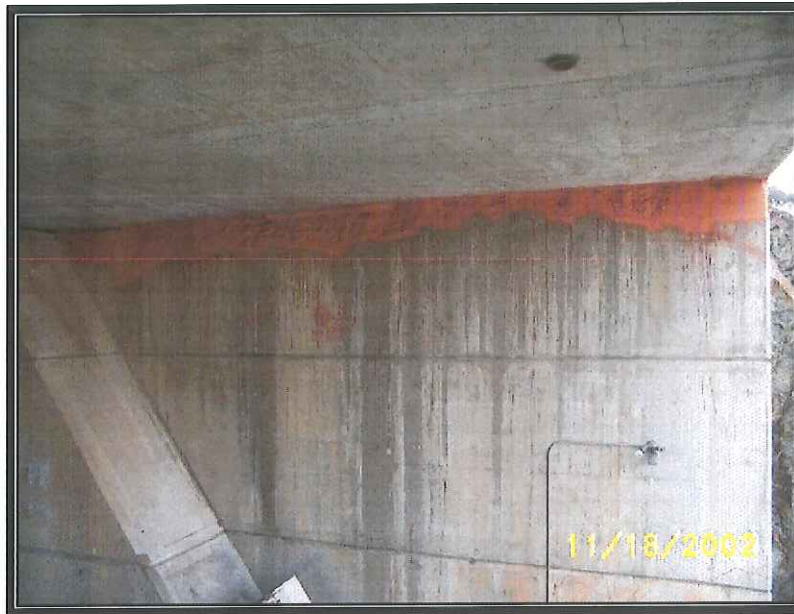
The radial gate repairs have been completed. In addition, one trunnion pin was removed for inspection and found to be in satisfactory condition. Concrete spalling continues at the left and right abutments of the spillway boat ramp access bridge. The field office is monitoring the displaced riprap on the upstream slope of the dam as requested during the last inspection. O&M is reviewing the instrument program, and has contracted with DOE to develop a new PMF.

1. This picture shows the spalling at the left abutment of the spillway bridge deck. Conditions at the right abutment are similar. Fresh paint has been sprayed on the spalled areas in order to track the progress of deterioration. Photograph courtesy David Panec, O&M.
